JOINT PHOTOGRAPHIC INTELLIGENCE BRIEF

SUBJECT : Type III (Air-to-Surface Missile) NO : PIC/JB-23/60  
Storage Site DATE: 15 March 1960  
LOCATION: Khorol East, Ostrov Gorokhovka WAC : 282; 153; 051  
and Severomorsk Airfields, USSR

REQUIREMENT: SI/R-12/59. Examine the Type III storage sites at Khorol East, Ostrov Gorokhovka, and Severomorsk Airfields for any similarity to nuclear weapons storage sites.

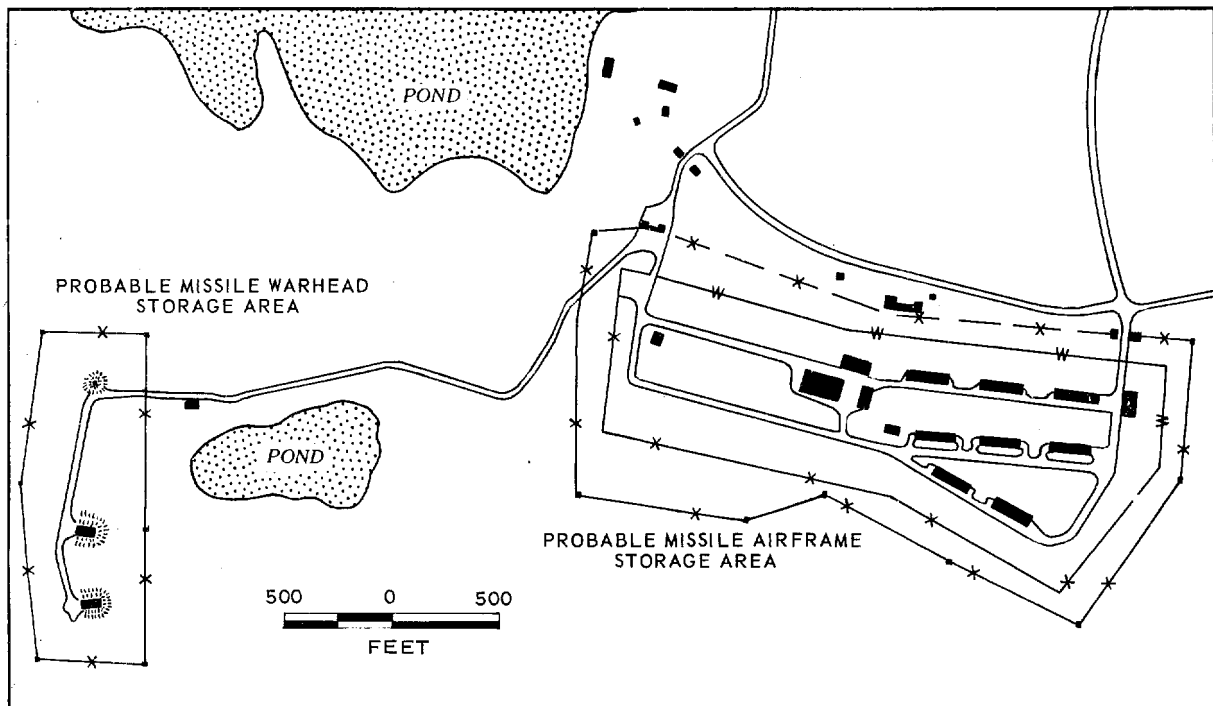
TYPE III STORAGE SITE AT SEVEROMORSK AIRFIELD

Each of the Type III (Air-to-Surface-Missile) sites examined in response to the above requirement consists of two storage areas, one of which is probably used for the storage of missile airframes and the other probably used for missile warhead storage. A graphic of the site at Severomorsk Airfield is included in this brief.

The probable airframe storage areas contain similar if not identical structures, including storage buildings, a checkout building, housing and administrative buildings, and other support-type structures. Variations occur in the number of storage and housing structures. Similar security measures are apparent at all sites including double fencing and guard towers. The inner fence is a board fence which precludes observation from the airfield. The areas at Ostrov Gorokhovka and Severomorsk have hills to the rear where

a wire fence has been used in place of a board fence. The area at Khorol East is situated on open ground and is completely enclosed by a board fence. There are no revetted or bunkered buildings in these areas.

The probable warhead storage areas have general similarities, and as a group appear similar to Soviet conventional high explosive storage. They contain revetted and non-revetted storage buildings, and small earth-covered bunkers. Security around these areas consists of one and probably a second wire fence, with no evidence of board fencing.

The airframe storage area at Severomorsk and the warhead storage areas at Khorol East and Severomorsk were under construction at the time of photography.
